Limited Visual Dam Safety Inspections

Kaneohe Dam

Oahu, Hawaii

May 2006

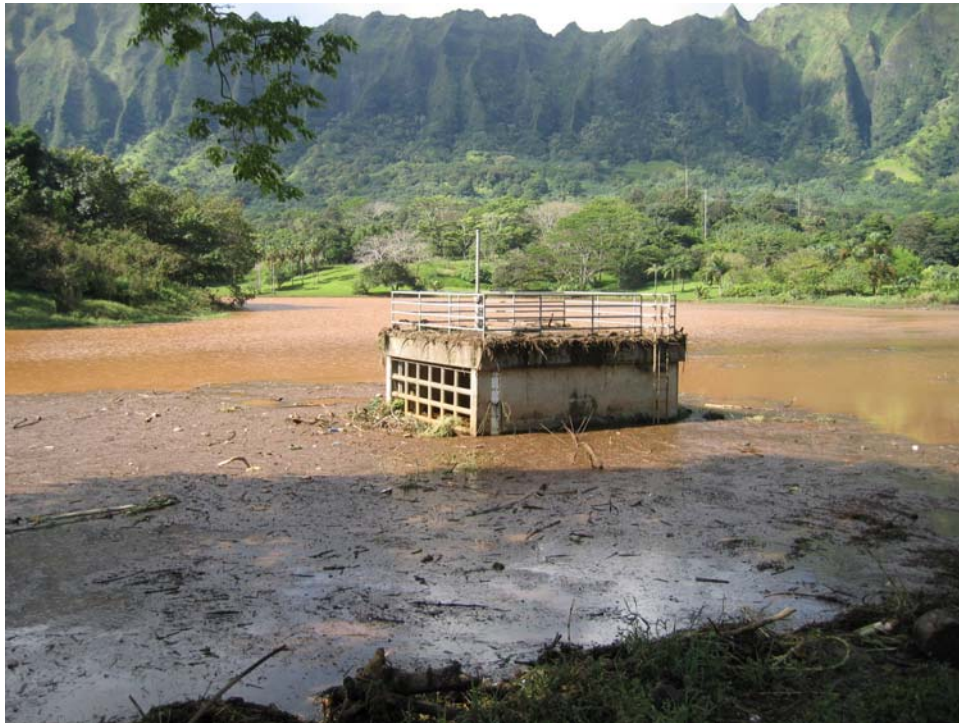
- a. The reservoir was not inspected and only observed from the intake structure of the outlet works.
- b. The reservoir appeared to be in fair to poor condition and requires corrective action.
- c. Trees have been planted by the Botanical Gardens near the intake for the outlet works. These should be removed to reduce the debris from entering the intake.

Photo 1 Intake for outlet works.

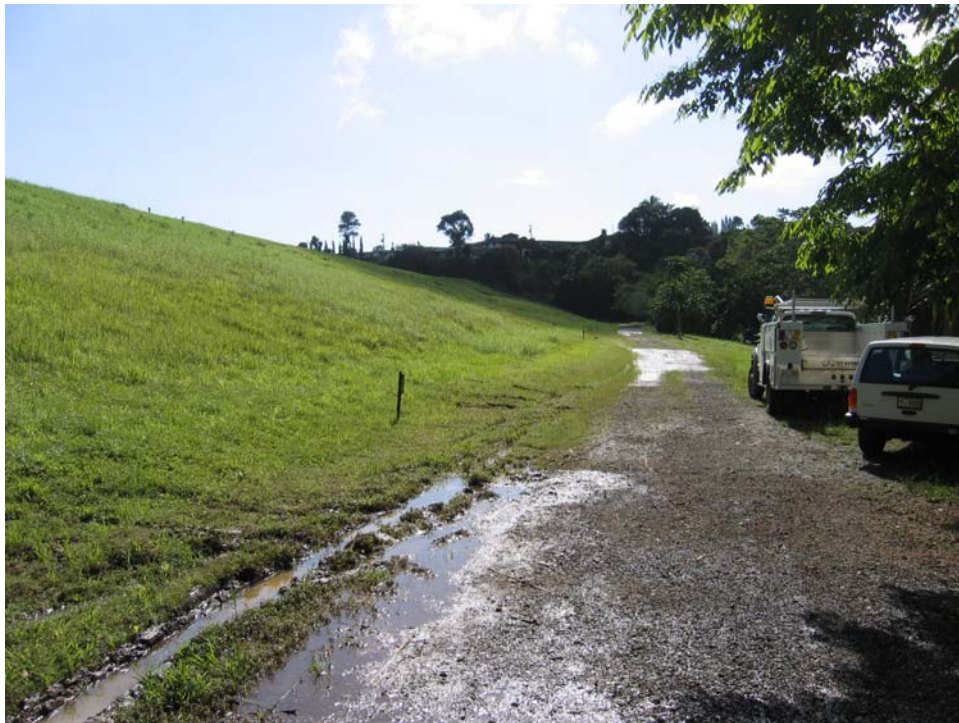
Photo 2 Upstream toe.

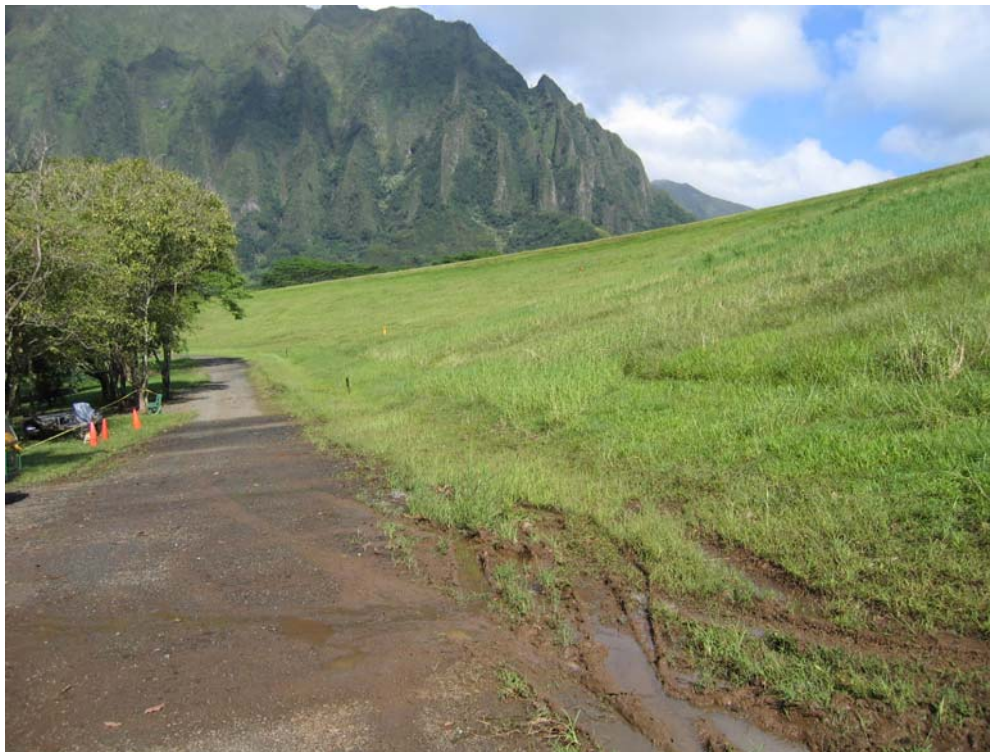
- a. The upstream slope appeared to be in satisfactory condition, no corrective actions are required at this time.

Photo 3 Upstream slope.

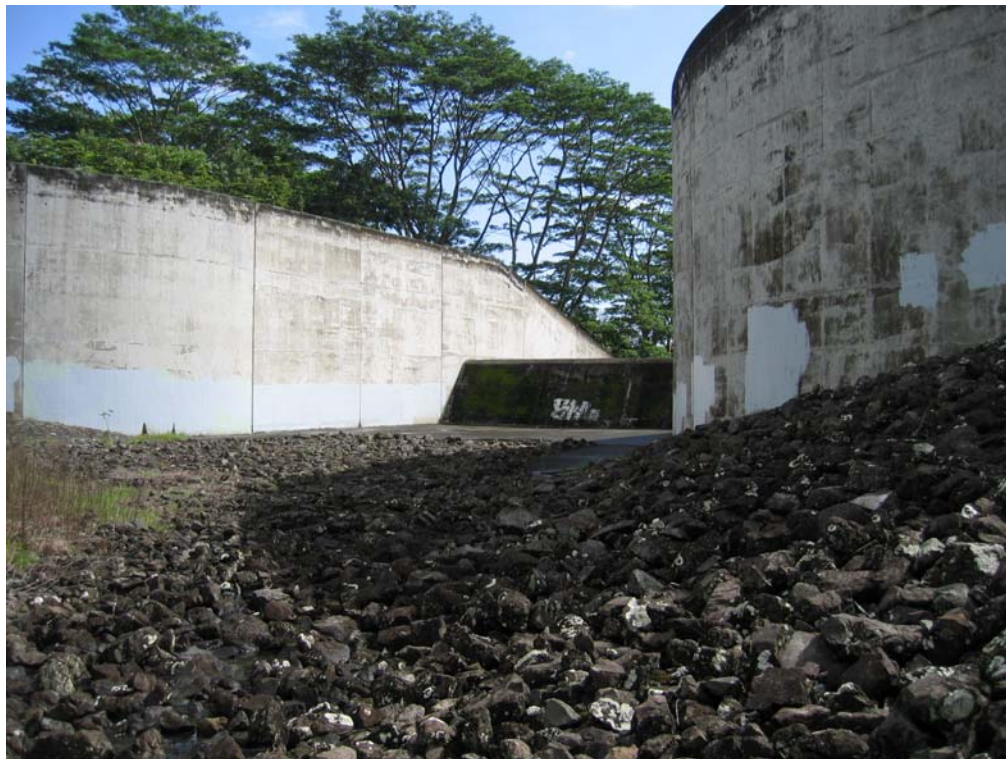
Photo 4 Entrance to spillway.

- a. The Spillway appeared to be in satisfactory condition, no corrective actions are required at this time.
- b. Trees are unacceptable in the spillway channel and approach. Take corrective action to address the woody vegetation problem and repair the damaged area.
- c. Clear vegetation near spillway entrance.

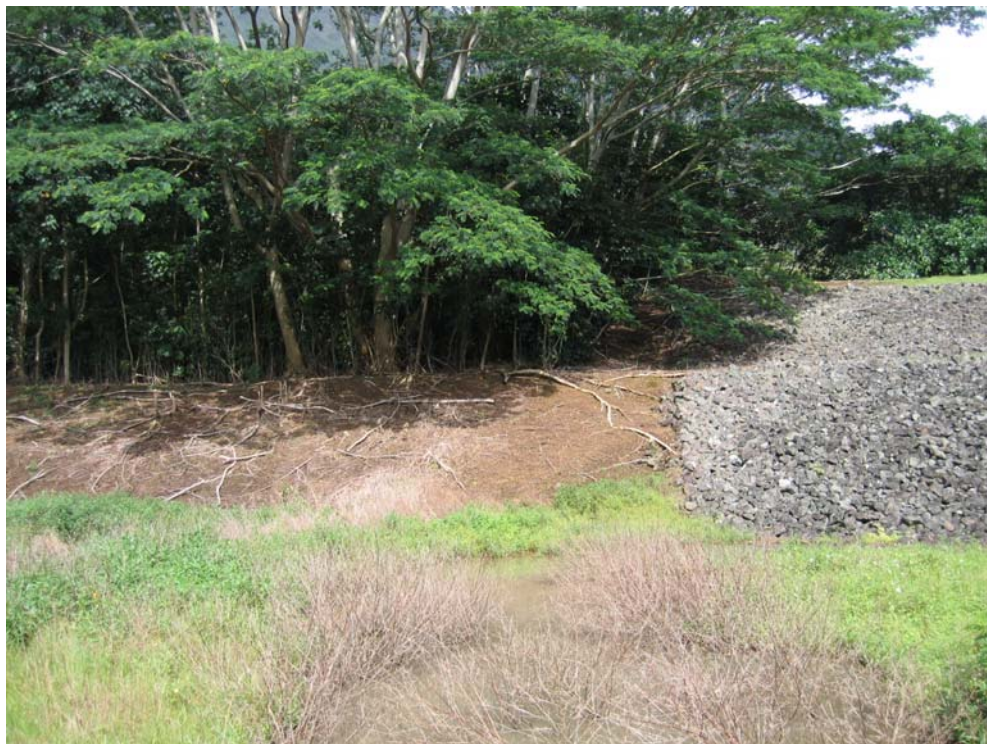
Photo 5 Trees along spillway slope.

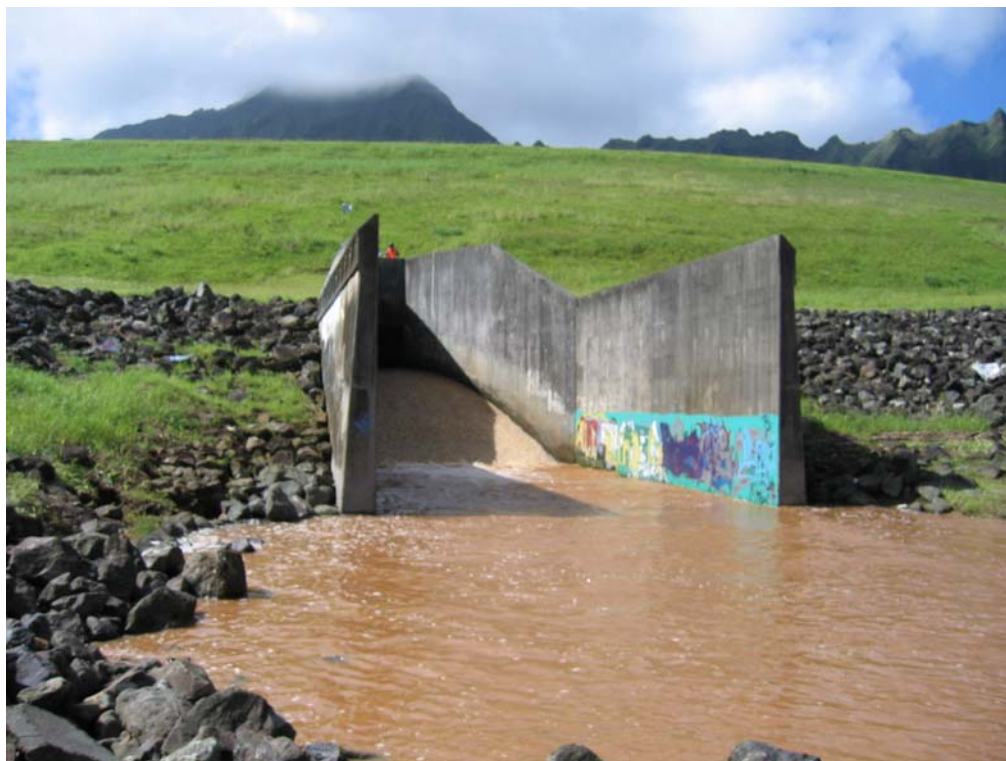
- a. The outlet works appeared to be in satisfactory condition, no corrective actions are required at this time.

Photo 6 Outlet works.

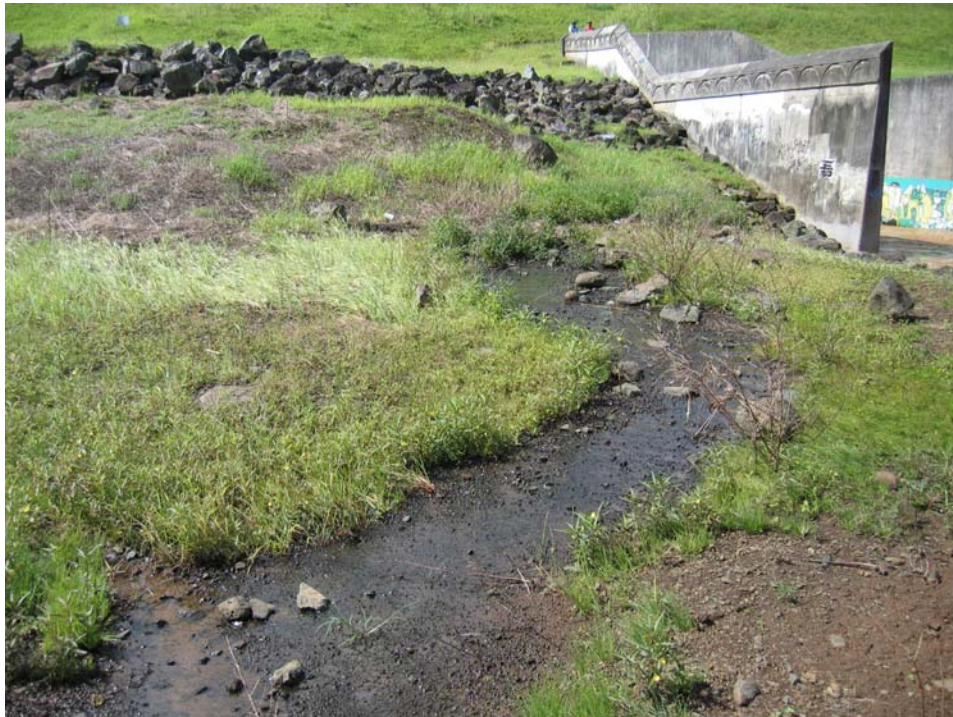
An area was noted along the toe that could be a possible seepage spot. This location was observed near the right side of the outlet works. The water that was seeping appeared to be moving relatively slow and was clear.

Photo 7 Seepage near outlet works.

- a. The abutments/toe appeared to be in satisfactory condition, no corrective actions are required at this time.
- b. Seepage/Ponding water was observed. Monitor and conduct further investigation to locate the source of water and extent of any possible hazardous or developing condition.

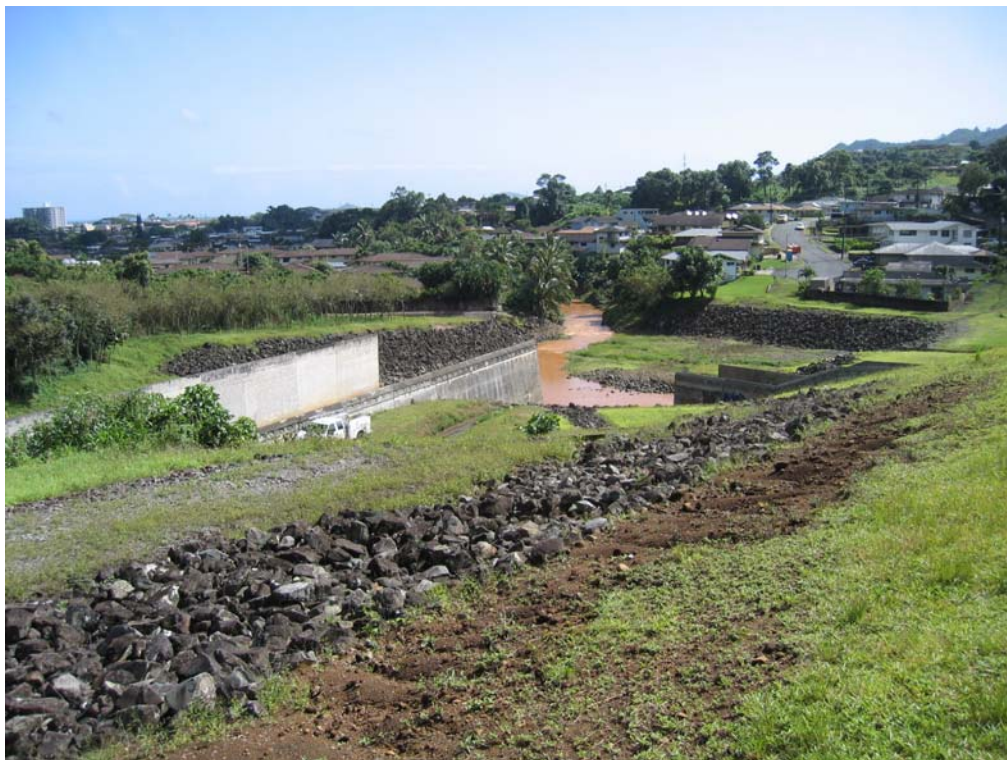
The downstream slope was in good condition with the exception of some areas with little vegetation, loose soil and small ruts on the downstream left side of the dam.

Photo 8 Downstream erosion channels.

- a. The downstream slope appeared to be in satisfactory condition, no corrective actions are required at this time.
- b. Rut and/or Gully erosion was observed on the slope, which requires maintenance and/or repair. Description: Fill, compact and regrade ruts. Low grass should be established to reduce erosion.

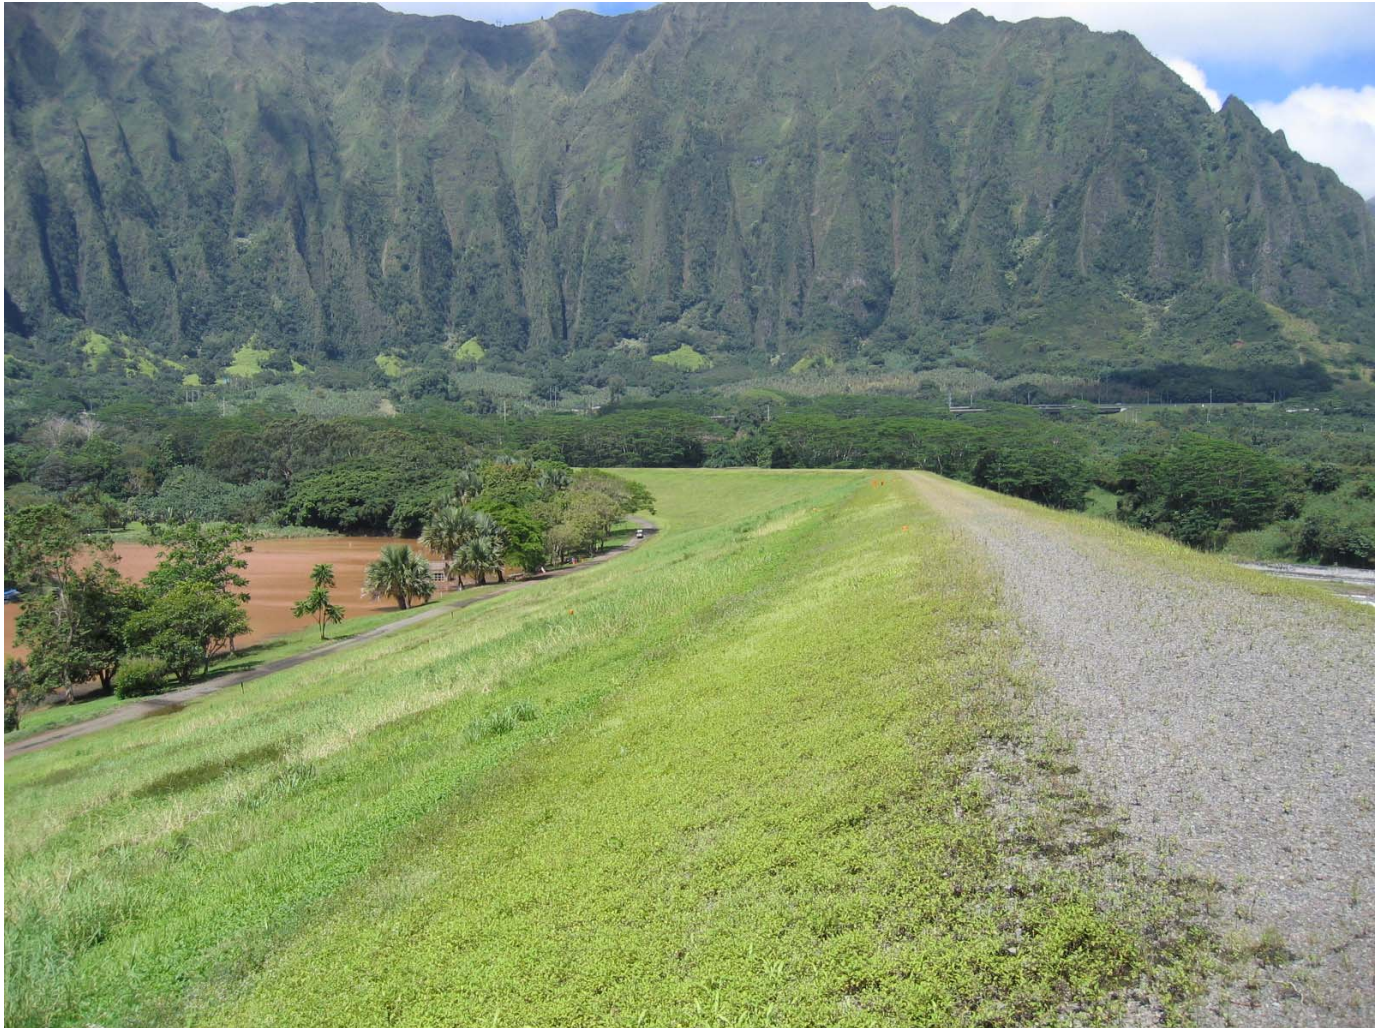
Vegetation was observed on the edges of the crest. These were primarily low grass.

- a. The dam crest appeared to be in satisfactory condition, no corrective actions are required at this time.
- b. Access along the crest was satisfactory.

Photo 9 Crest
